CONNECTICUT RIVER BASIN
WHATELY, MASSACHUSETTS

SOUTH DEERFIELD
MA 00522

PHASE I INSPECTION REPORT
NATIONAL DAM INSPECTION PROGRAM

JUNE 1979

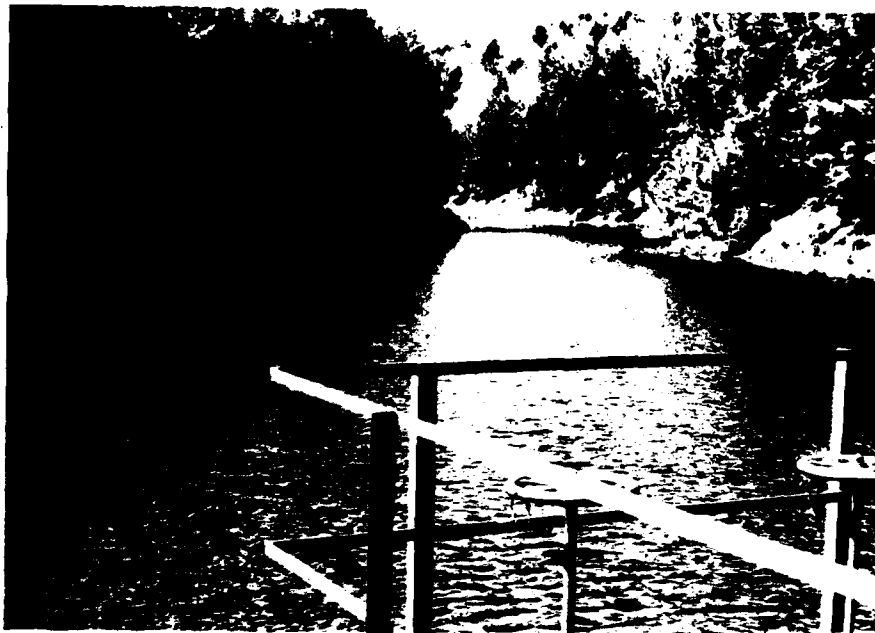
The upstream reservoir is the Roaring Brook and is shown in photo 10. A more detailed description of the drainage area is included in Section 1.3.a.

PHOTO NO. 10 - Upstream reservoir viewed from
intake structure.
